IMMEDIATE RESPONSE ACTION PLAN Status Report 3

Barnstable Municipal Airport
Hyannis, Massachusetts

RTN 4-26347

April 2018

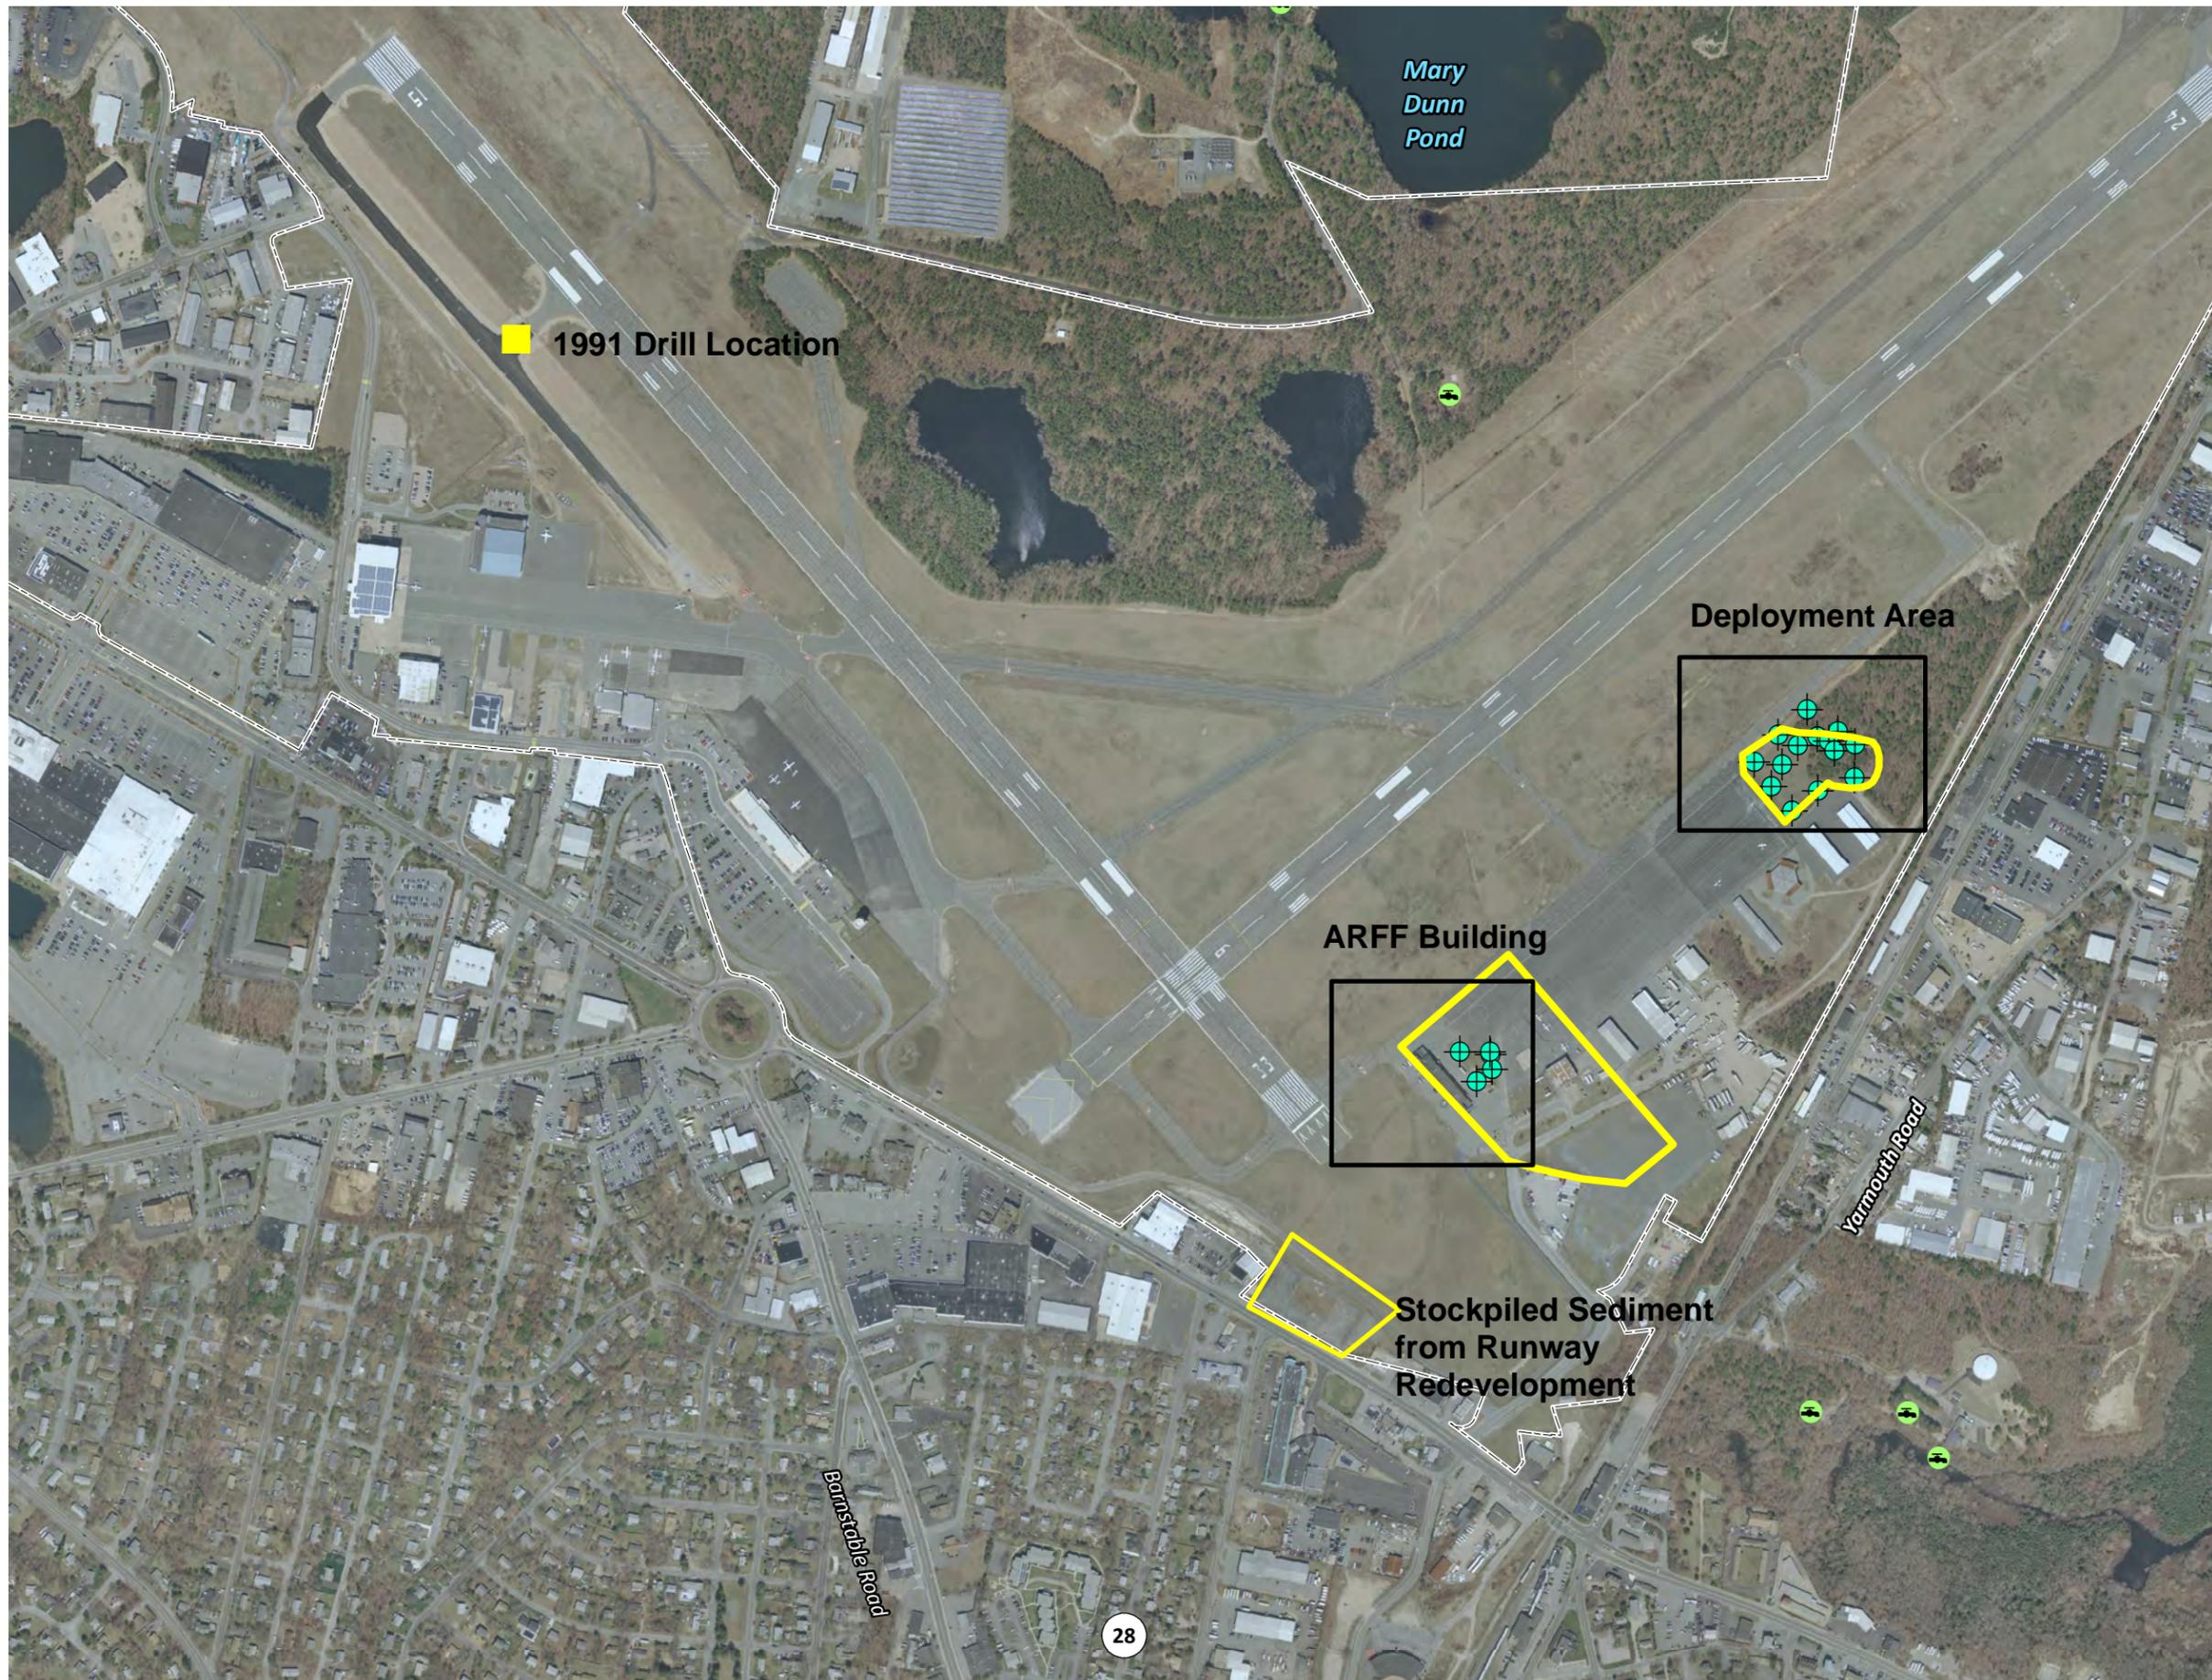
Figure 4

- An initial round of three soil samples were taken on December 6, 2016 as reported in the first status report. One sample was taken from each location where it was determined that aircraft fire fighting foam (AFFF) had been used at the Airport, including the site of an airplane crash in 1991, the deployment area, and the drill location along the dirt road adjacent to the deployment area (See Figure 4).

Location of Known
 ARFF Use and Storage

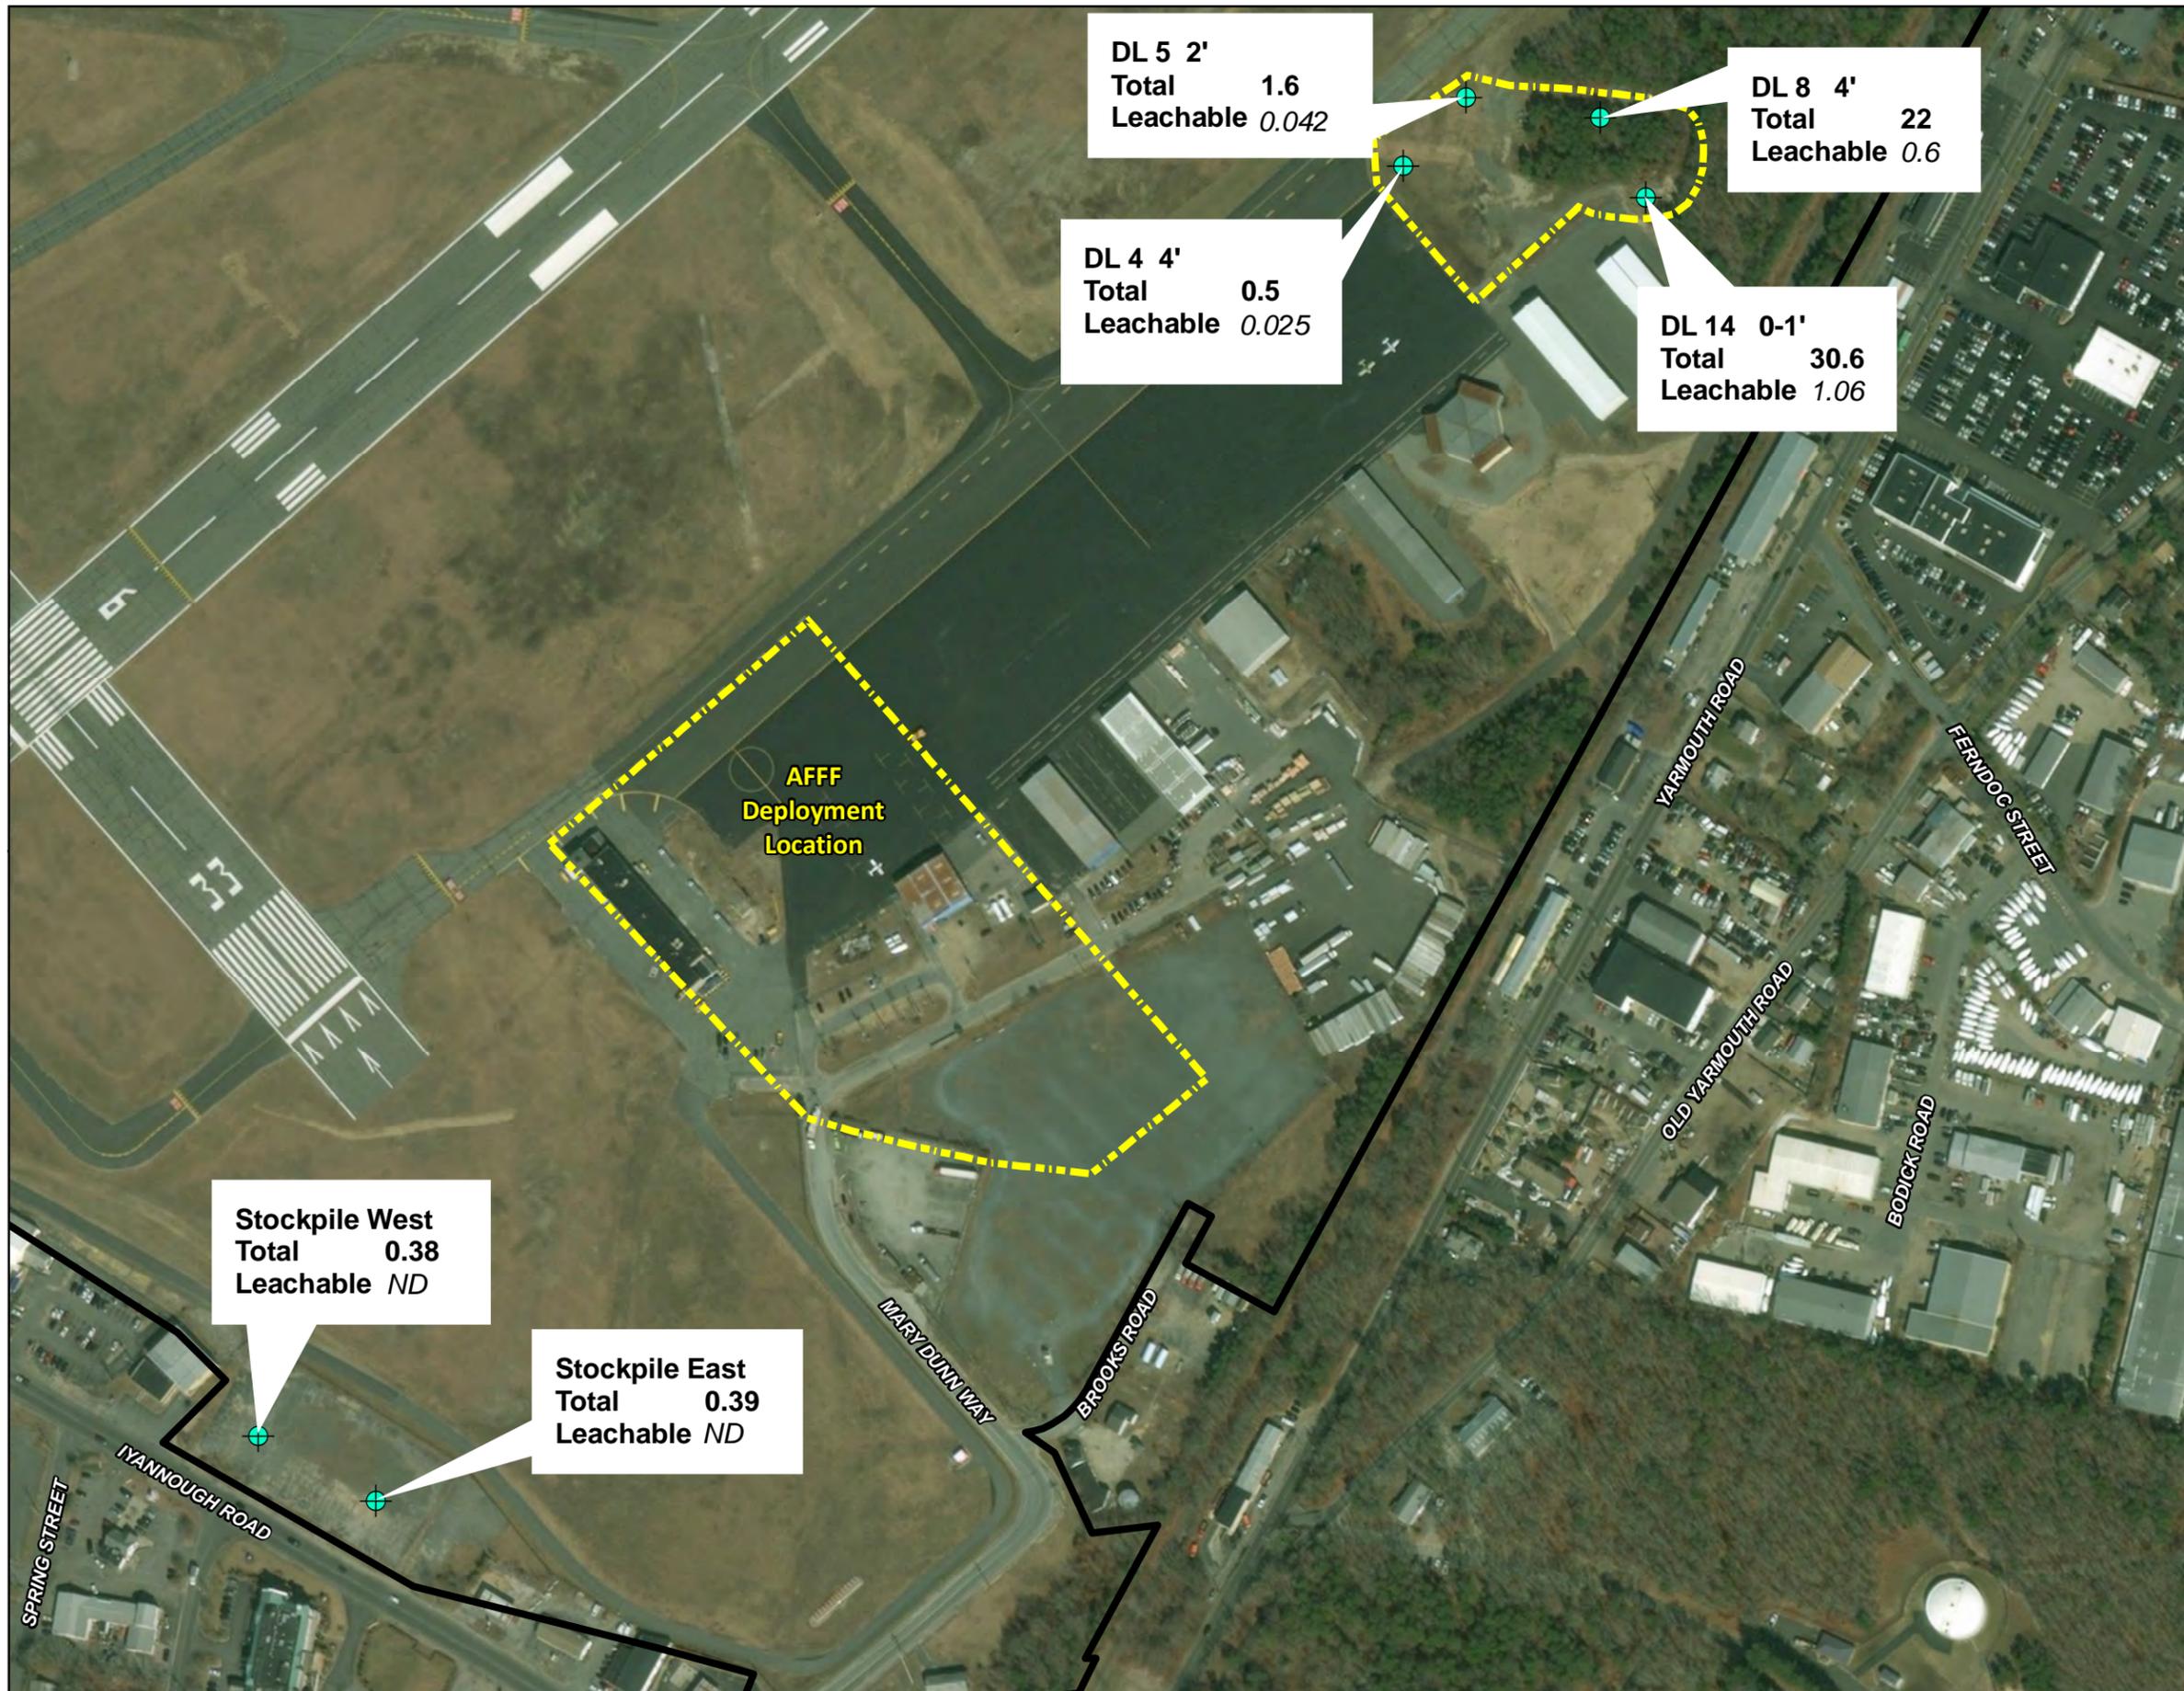
Figure 7

Six samples were analyzed using an SPLP test to evaluate the potential for leaching of PFAS compounds to groundwater. They include samples from the deployment area site, and the stockpiled sediments at the airport (Figure 7). The results of the analysis (Table 4) indicate

Note:
A field measured concentration in groundwater will vary from the laboratory leachate concentration based upon various field conditions.

Soil Leaching Results for
PFAS Compounds
Barnstable Municipal Airport
Hyannis, MA

- Six PFAS soil samples were also analyzed for leaching potential using an SPLP test. The chosen samples included four samples from within the boundaries of the PFAS sites at the airport and two samples from runway reconstruction soils stockpiled at the airport. Results of these tests were provided to HW by the Laboratory in early January, 2018 (Figure 7).
