DRAFT IMMEDIATE RESPONSE ACTION PLAN MODIFICATION

Barnstable Municipal Airport
Hyannis, Massachusetts

RTN 4-26347

October 2019

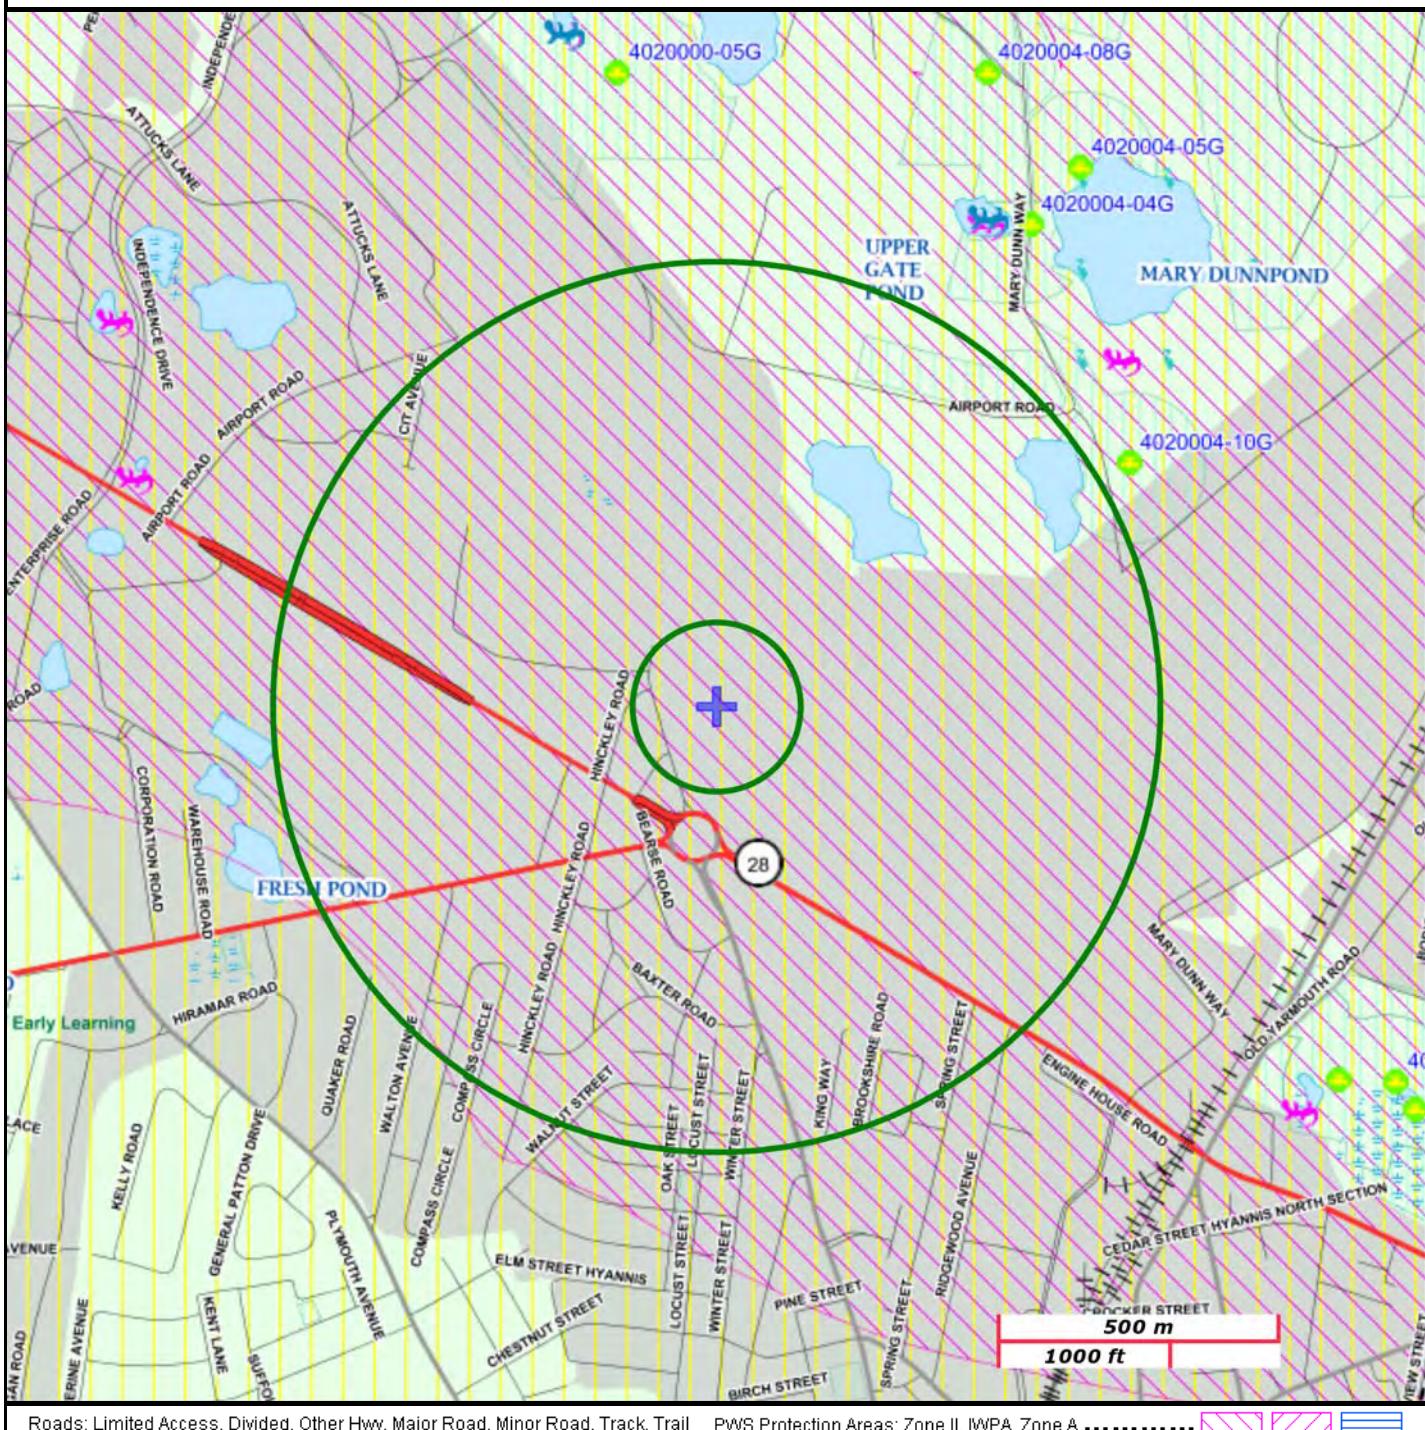
FIGURE 3 - Priority Resource Map

According to MassGIS and the MassDEP Priority Resource Map (Figure 3), there are no Areas of Critical Environmental Concern; local, state, or federal protected open space; fish habitats; and, habitats of Species of Special Concern or Threatened or Endangered Species within 500 feet of the Airport. There is an area including Rare or Endangered species located approximately 500 feet north of the Airport boundary near Mary Dunn Pond.

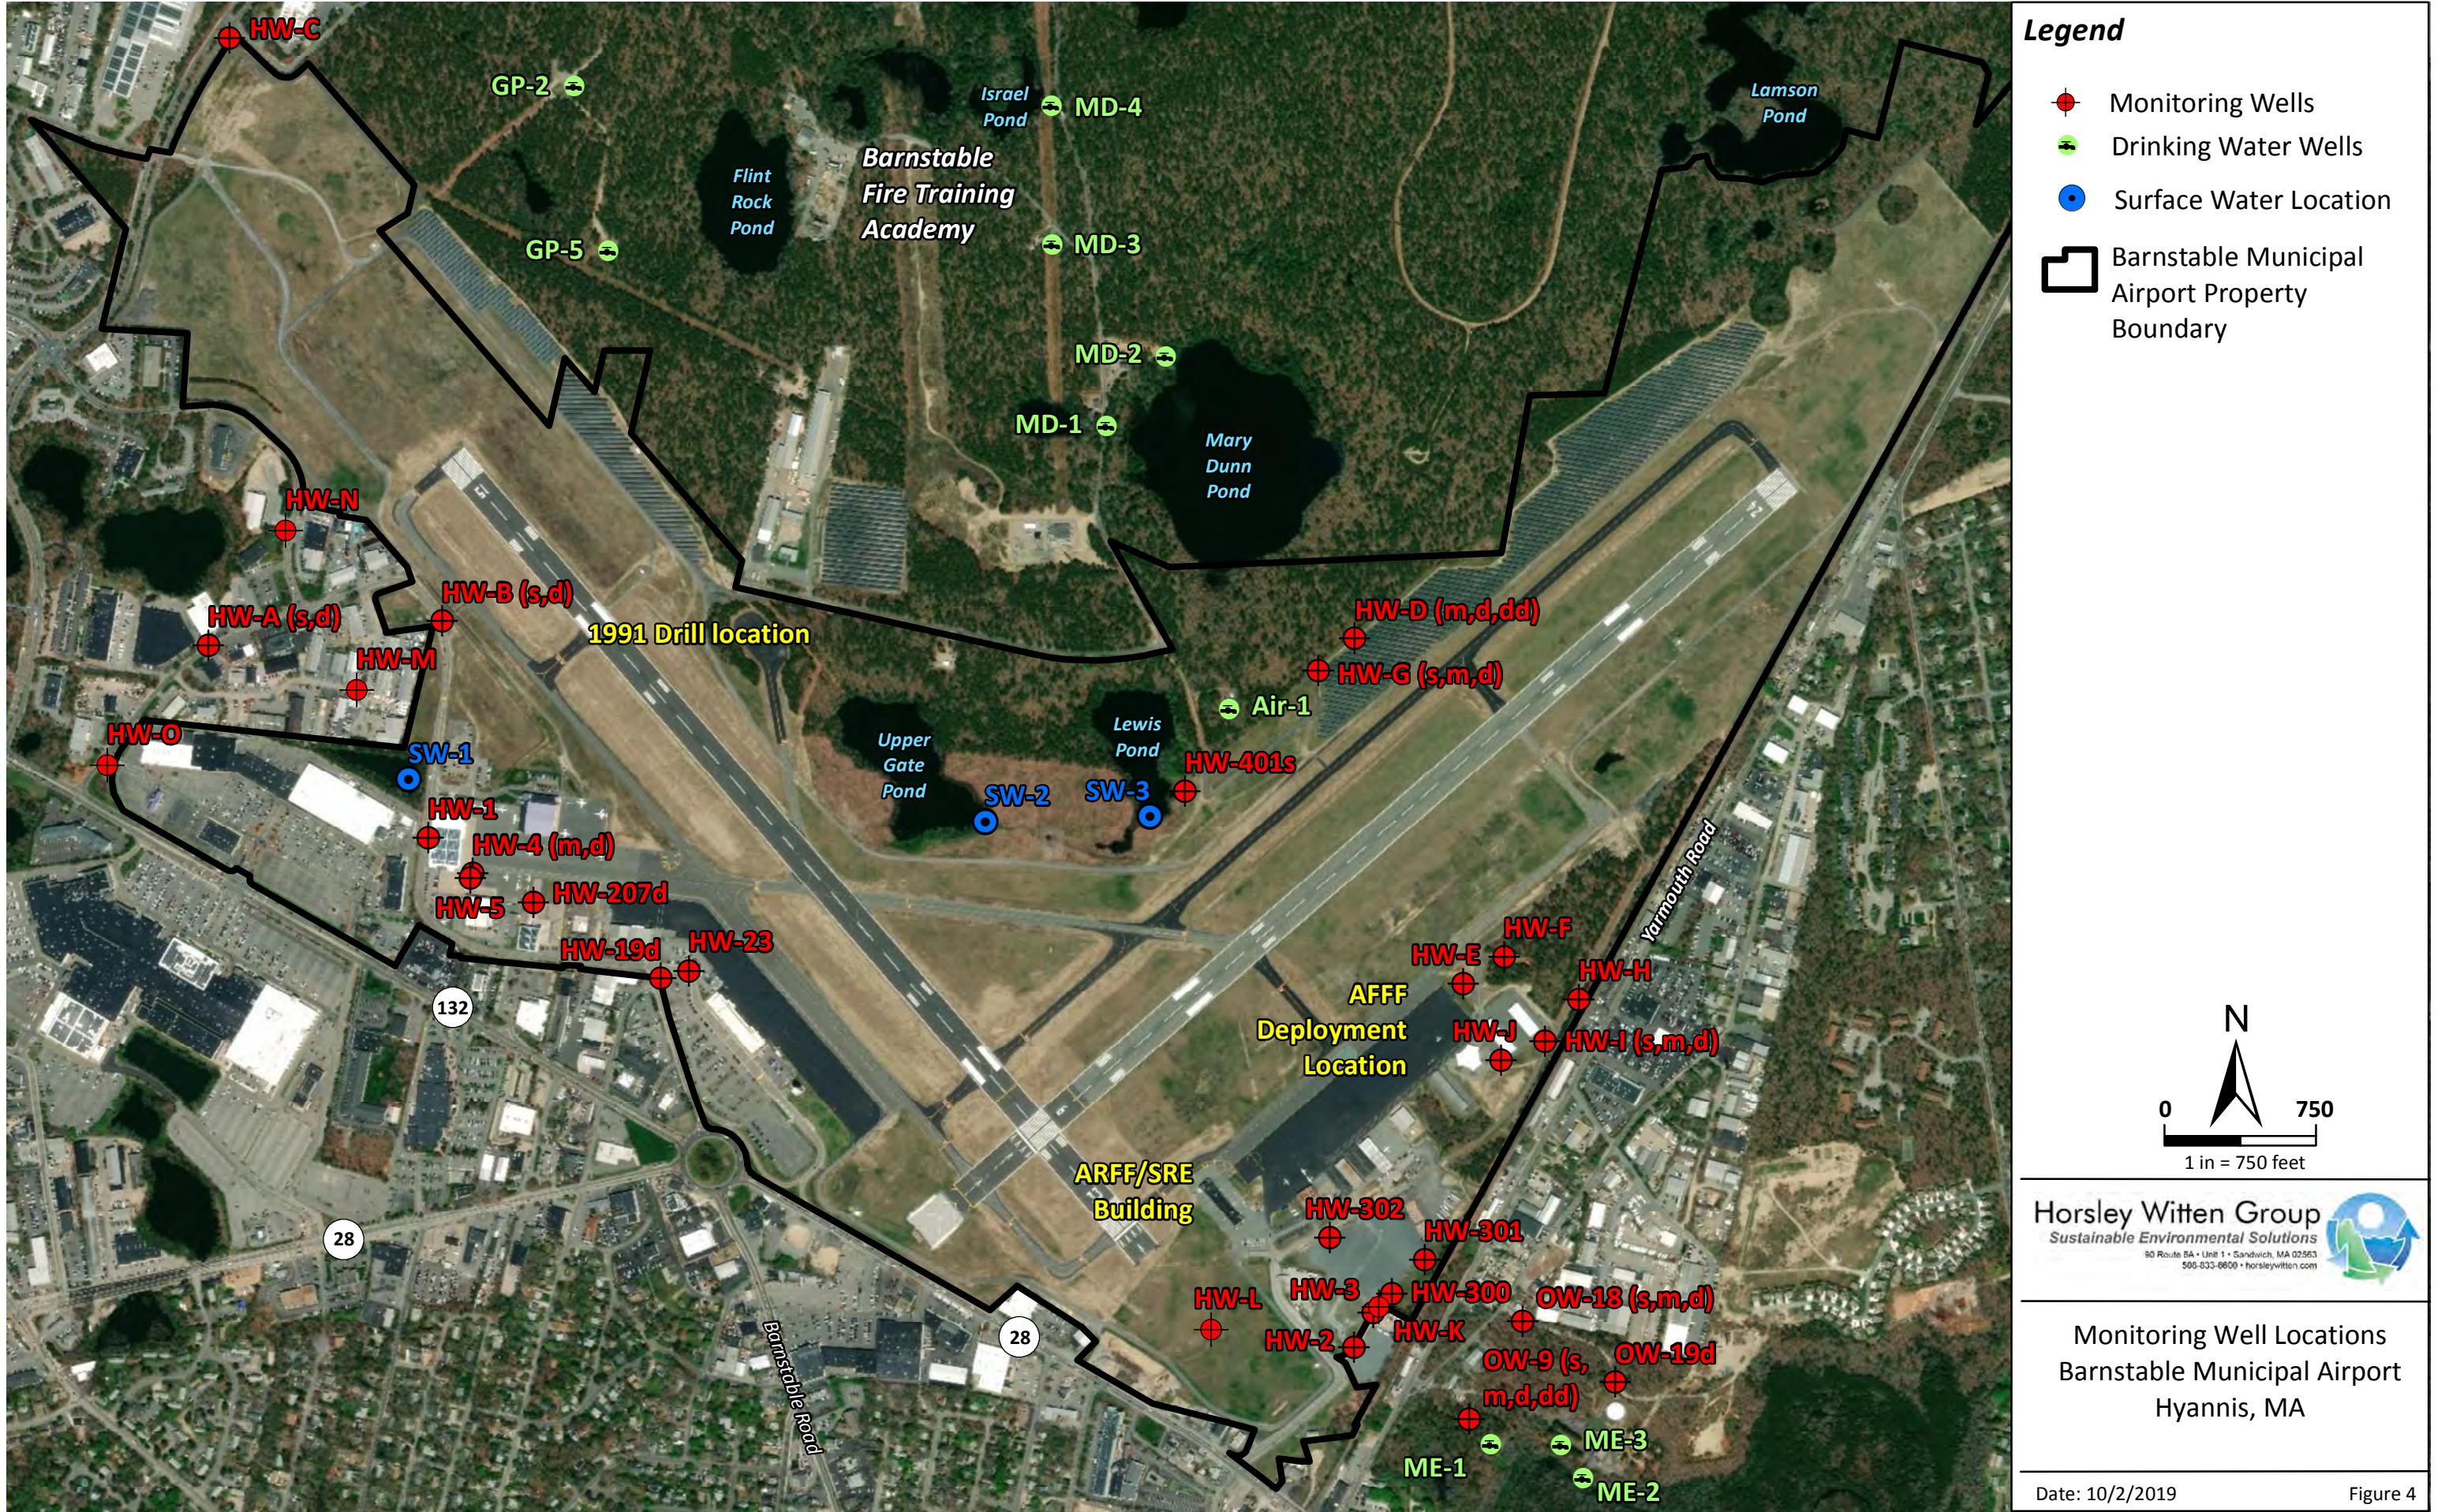
In July 2015, HW sampled groundwater from seven monitoring wells on and off the Airport property for analysis of 1,4-dioxane. The contaminant was detected in well OW-9DD at a concentration of 0.93 ug/L, above the 0.30 ug/L standard for 1,4-dioxane. This well is located off Airport property, within the Maher Wellfield property, and is screened from 77 to 87 feet BGS. All samples taken from the other wells at the Airport property did not contain 1,4-dioxane above laboratory reporting levels. Subsequent testing in 2017 of 11 groundwater wells only detected 1,4-dioxane at OW-9DD, OW-19D and OW-18D which are all located off Airport property and within the Maher Wellfield property. An additional well was installed at the Airport in June 2019 as a final attempt to verify that the Airport is not the source of 1,4-dioxane at the Maher Wellfield property. Sampling of this well and select off-site wells for 1,4-dioxane was conducted in August. Testing of an additional six wells at the Airport for 1,4-dioxane was conducted on September 27, 2019 and laboratory results from these wells are still pending. The potential source(s) and nature and extent of the 1,4-dioxane are still being evaluated. Tabulated analytical data (excluding the recent samples collected in September) is included on Table 1 and monitoring well locations are indicated on Figure 4.

In response to the August 4, 2016 NOR/Request for Information (“RFI”) the Airport conducted additional groundwater investigations and collect samples for laboratory analysis. As described in the December 2016 IRA Plan, these efforts were focused on suspected PFAS contamination locations on the Airport. Based on the results of 75 soil samples and 65 groundwater samples collected at the Airport between 2016 - 2019 and interviews with Airport staff regarding the use of aqueous film forming foam (AFFF) as required by the Federal Aviation Administration (“FAA”), PFAS has been identified in two distinct areas at the Airport. These areas are identified as the Air Rescue and Fire Fighting (ARFF) Building Area and the Deployment Area. These areas are identified with a yellow line on Figures 5 and 6, respectively. Tabulated analytical data is included on Tables 2 through 4 and sampling are indicated on Figures 4, 5 and 6.
